Monitoring and Impacts of Leakage from Sub-Seafloor CO₂ Storage Sites

Rachael James

Ocean and Earth Science, University of Southampton, UK

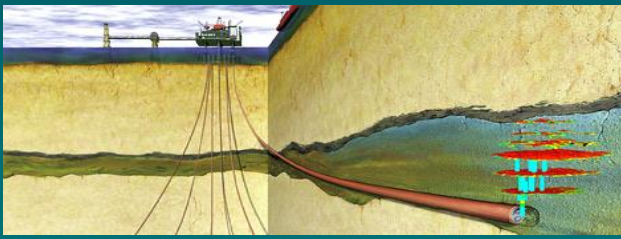
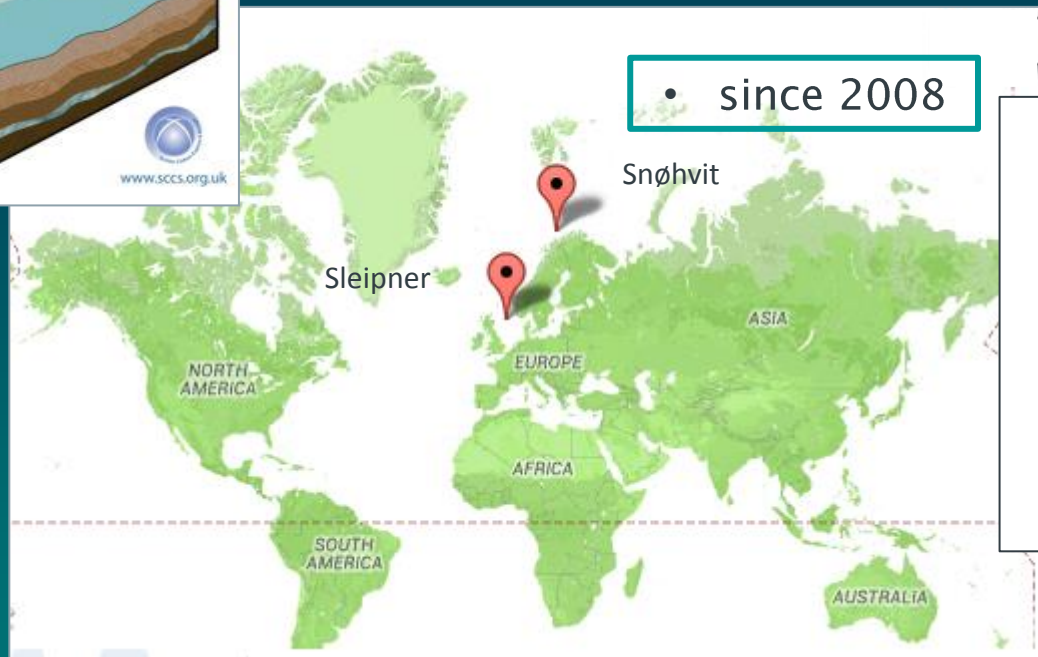
Longest operated site (since 1996)
 1 Mt CO₂ a⁻¹

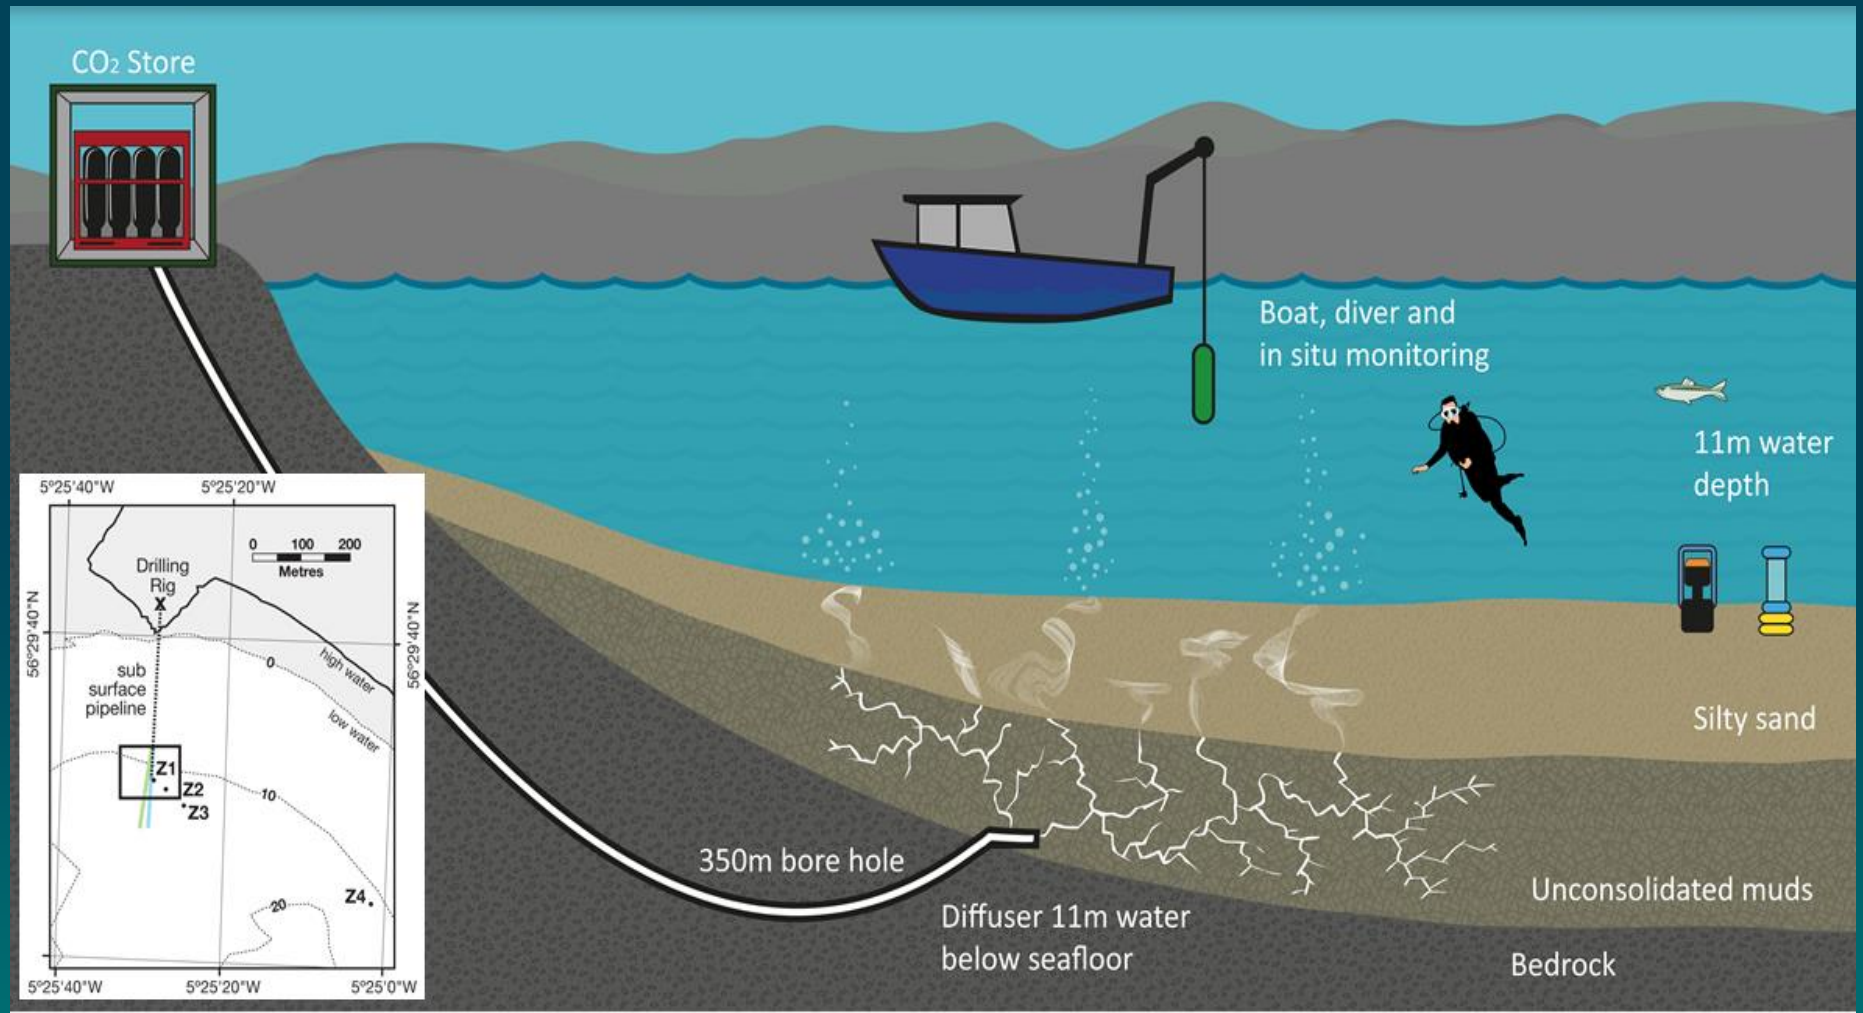
May
2012

Pre-release

Injection

Recovery

Sept
2012

Summary of key findings

- CO₂ leakage was detectable at relatively low flow rates (20–210kg CO₂ d⁻¹):
 - Geophysical imaging (chirp/boomer/multibeam)
 - Biogeochemical sensors (pCO₂/pH/ORP)
 - Direct observation (camera, video, divers)
- CO₂ bubbles were:
 - Easily recorded (pCO₂, hydrophones, imaging)
 - Sensitive to hydrostatic pressure
 - Represented only a fraction (<15 %) of injected CO₂
 - Reached shallower depths than expected
- Pore water and bottom water chemistry was impacted by CO₂ release, but:
 - Limited to release epicentre (~25 m diameter)
 - Quick recovery (within 20 days of termination of release)
 - Dissolution of CaCO₃ buffers pH
- Biological impacts appear to be limited
